THE BOEING COMPANY
Aerospace Group
Space Division

LARGE MOTOR CASE TECHNOLOGY EVALUATION

Contract AF 33(615)-1623

Report
June 1966

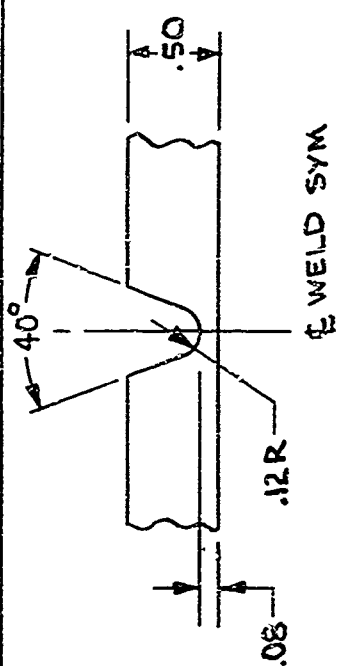
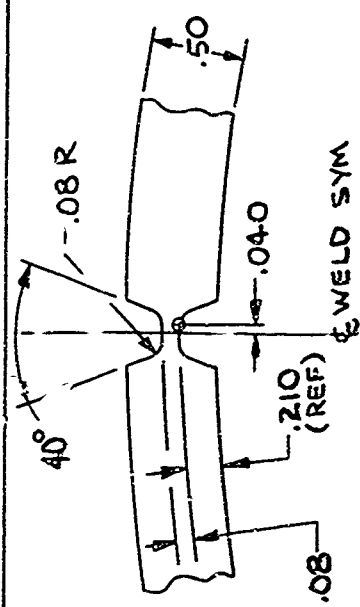
TABLE IV : 9Ni VESSEL WELD PARAMETERS

weld wire heats, and heat treatment temperature were identical to that of the test panels (see Tables I and II). Because of variation in equipment and part configuration, however, minor weld setting variations were required. These are shown in Table IV.

PASS	1	2 & ON	1	2 & ON
CURRENT	170 AMPS	210 AMPS	190 AMPS	225 AMPS
VOLTAGE	12	12-13	13	13
SPEED	6 IN/MIN	6 IN/MIN	6 IN/MIN	6 IN/MIN
WIRE FEED	24 IN/MIN	24 IN/MIN	22 IN/MIN	22 IN/MIN
SHIELD	He	He

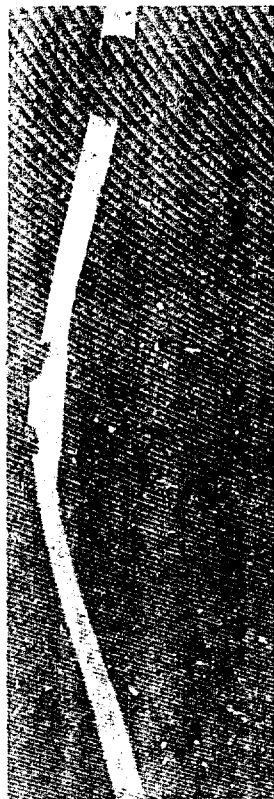
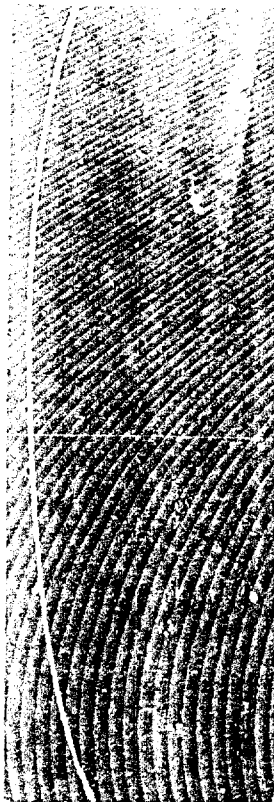
Figure 4: FAILURE ORIGIN

The tank failed at an ultimate pressure of 9840. Overall view of the failed tank is shown in Figure 3. Observation of the vessel indicated that failure initiated in the artificial flaw, the fracture progressing into both heads without fragmenting. All fracture surfaces except just under the flaw exhibited a full shear fracture. Close up views of the flawed area are shown in Figures 4a and 4b. A photomicrograph of the sectioned origin is shown in Figure 4c. It is seen that the fatigue crack extends into the grain coarsened region of the heat affected zone.

FATIGUE CRACK
DEPTH ——— EDM
